Erosion post ASD, can we predict ?

REDA ABUELATTA, MD, FSCAI, FACC
Consultant interventional cardiologist
Madinah Cardiac Center SA
National Heart Institute EG
Cardio-Egypt
February 2018

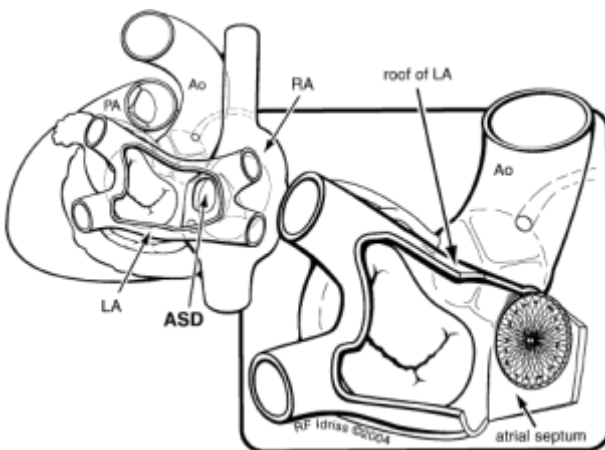
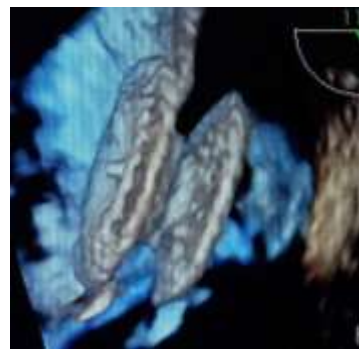
ASD Rims analysis

View of the ASD from the left atrium. The defect is in close proximity to the anterior and superior rim. Inset shows the ASDO in place. The edges of the device are in contact with the anterior and superior rims. The aorta has been moved anteriorly to show the structures. RA, right atrium; LA, left atrium; Ao, aorta; PA, pulmonary artery.

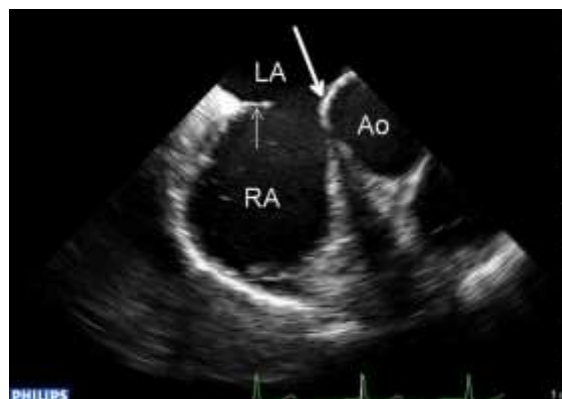
Short-axis view on TEE showing the absent aortic rim (long arrow) along the ascending aorta (Ao) and thin posterior rim (short arrow). RA, right atrium; LA, left atrium.

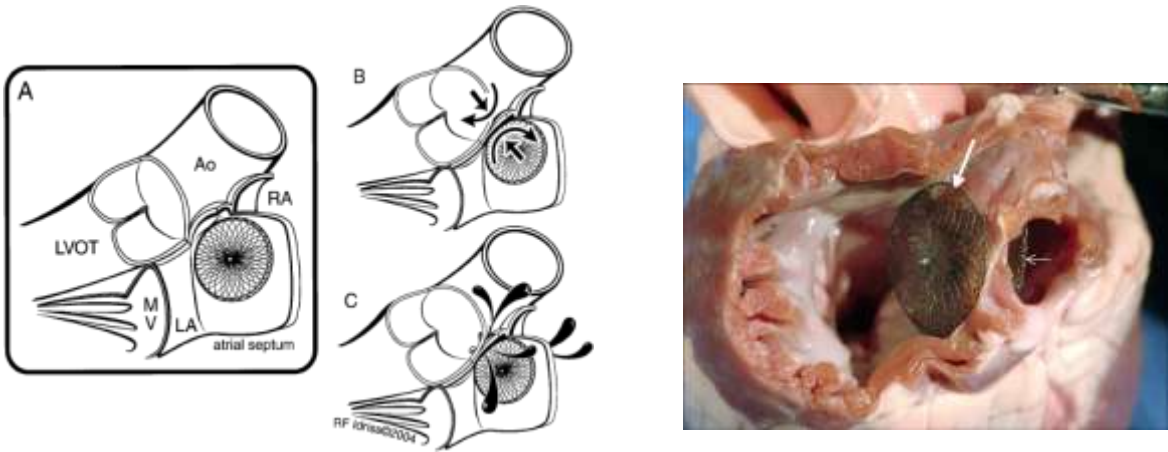
Mechanism of Erosion

A: ASO deployed in the ASD. Note the proximity of the free wall of the left and right atrium to the edge of the device.

B: With every cardiac cycle, the edge of the device acts like a **seesaw** that may result in bruising the atria and/or the aorta.

C: The device may ultimately erode the atrial wall and/or the aorta, causing hemodynamic compromise.

- The predominance of left atrial perforation with the ASO device may relate to the **larger left atrial disk**.
- All atrial perforations involved the roof of the atria (superior rim) and lead directly into the pericardium.
- Decreased right atrial cavity with elimination of the left-to-right atrial shunt could bring the device into contact with the atrial wall.
- **So** deficient superior or aortic rim may be associated with increased risk of an atrial perforation. Oversizing a device could increase this risk.
